**SR 166 MP 4.52 Olney Creek (15.0201 0.90):
Preliminary Hydraulic Design Report**

**Beth Rood PE, Project Manager
Certification FPT20-07944
HDR Engineering, Inc.**

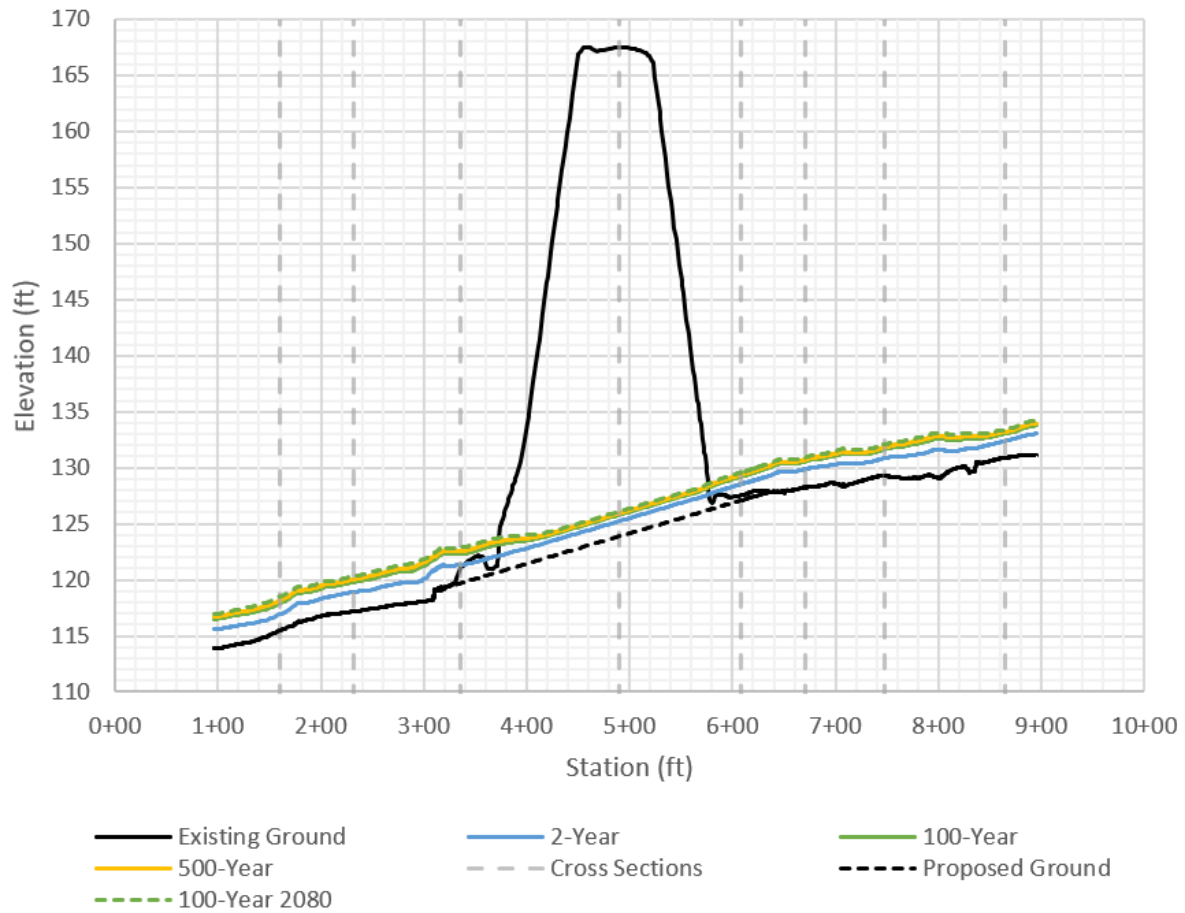
Figure 52: Proposed-conditions water surface profiles

In differences between the existing and proposed conditions, the greatest change occurs just upstream of the culvert because the backwater from the existing culvert is removed. Under proposed conditions, the enlarged structure removes the backwater upstream of the culvert. WSEL drops by as much as 4 feet from existing to proposed conditions at the culvert inlet. Shear stress is generally higher in the upstream reach because the existing culvert backwater effect is eliminated. In the downstream reach, shear stress is relatively similar between the existing and proposed conditions, though higher for the projected 2080 100-year flows. Proposed-conditions main channel hydraulic results are summarized for the upstream and downstream cross sections in Table 13. Refer to Figure 51 for cross-section locations and Figure 45 for the alignment used for reporting proposed results. The longitudinal profile is shown in Figure 52, and a typical section through the structure is depicted in Figure 53. Proposed-conditions 100-year velocities are depicted in Figure 54. Figure 55 shows the same velocity map with 2080 predicted 100-year velocities. Average floodplain and main channel velocities are summarized in Table 14.

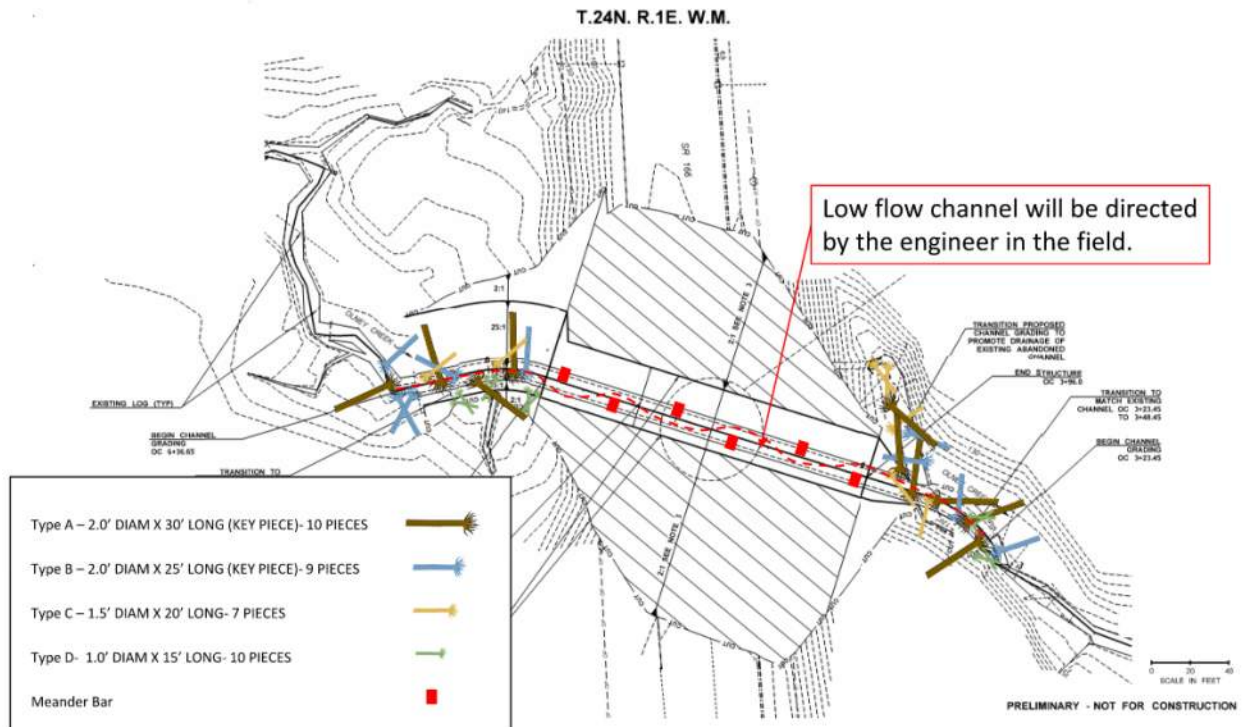
Figure 56: Conceptual layout of habitat complexity features assuming culvert

proposed structure wall, and will have similar function to the natural features observed in the reference reach.

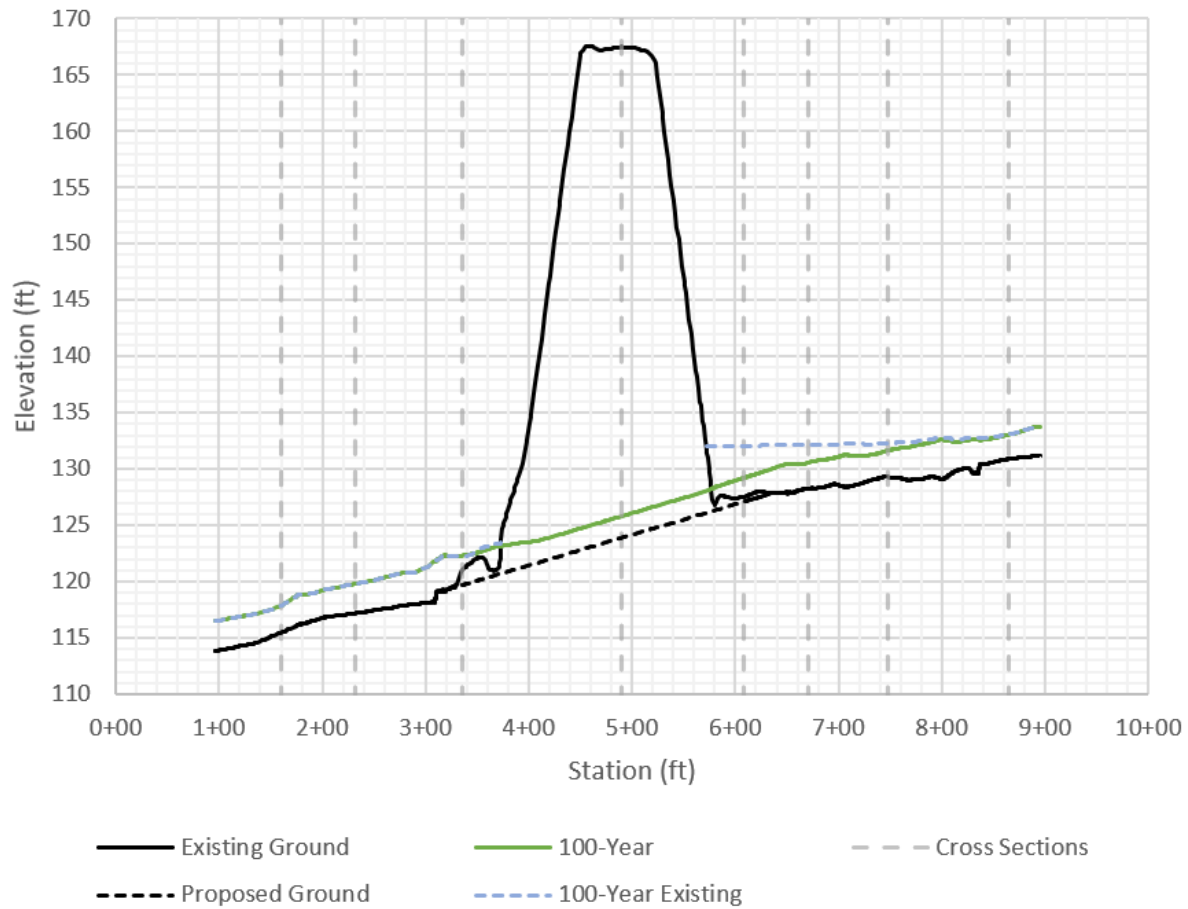
Figure 58: Existing and proposed 100-year water surface profile comparison

the outlet of the proposed culvert, with a maximum increase of WSEL of approximately 0.2 foot. Properties surrounding the crossing are much higher in elevation than both the existing and proposed flood elevations.

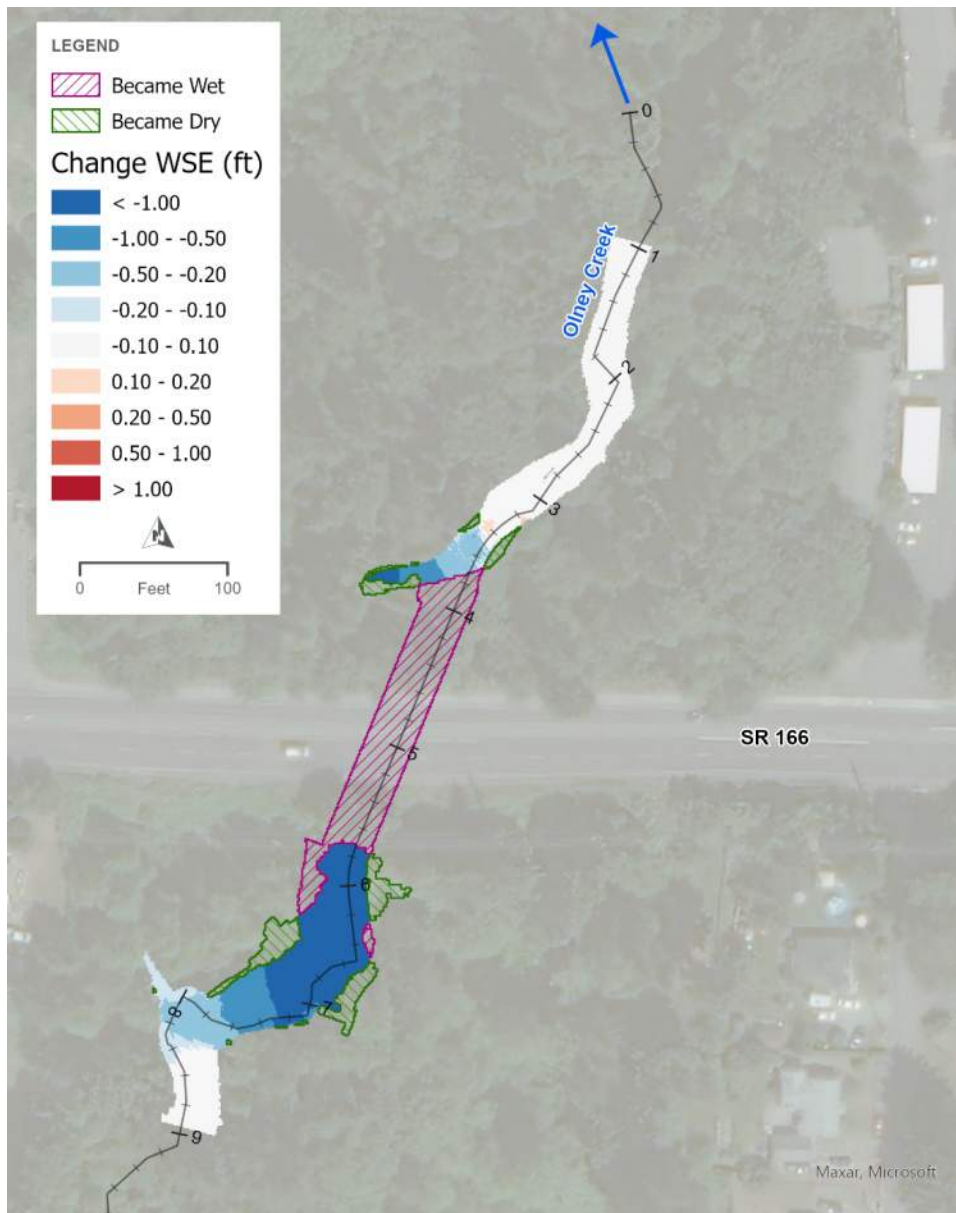
Figure 59: 100-year water surface elevation change from existing to proposed conditions

Values within Figure 59 indicate the feet of rise or fall in WSEL from existing to proposed conditions. Purple and green hatching represent new water surface extents and water surface extents that are no longer wet, respectively, under proposed conditions.

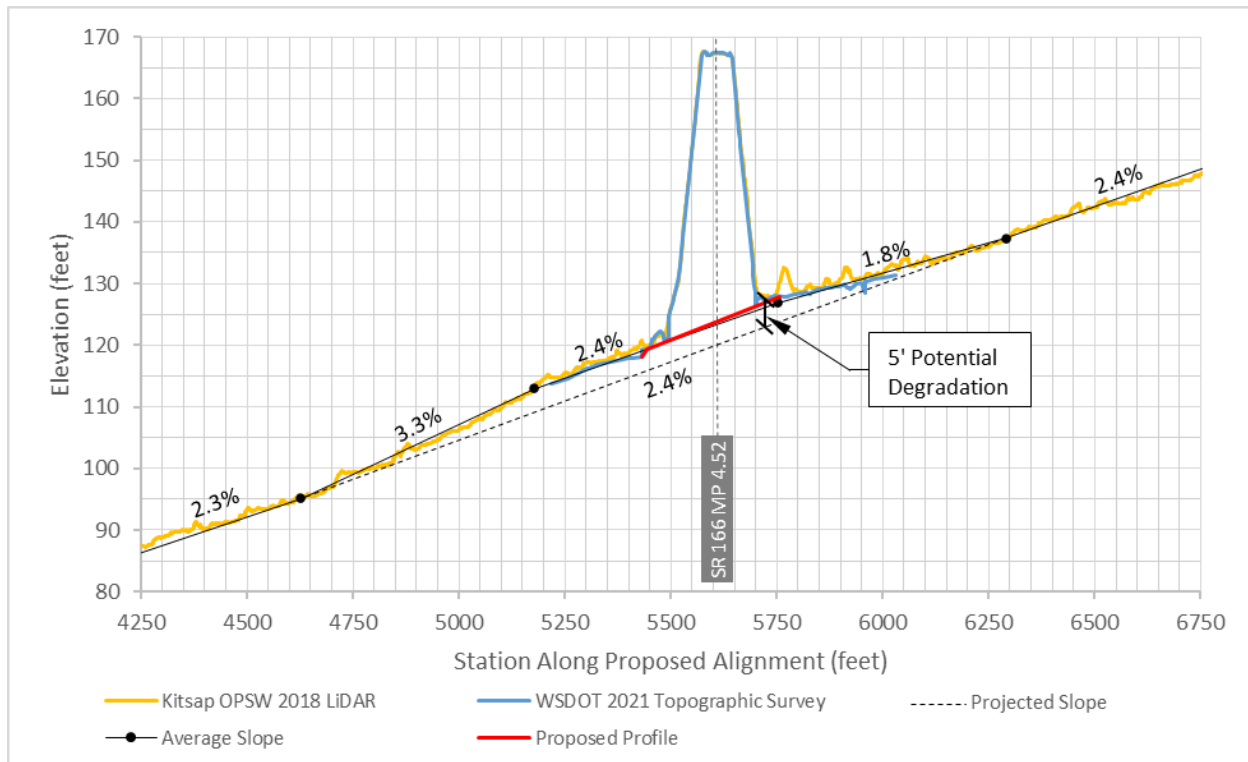
Figure 60: Potential long-term degradation at the proposed structure upstream face

Long-term degradation potential was visually estimated to be approximately 5 feet at the proposed structure inlet based on projecting the prevailing slope of 2.4 percent upstream through the crossing, as shown in Figure 60. See Section 2.8.4 for more information on the longitudinal profile. Localized sedimentation may occur because of the large amount of LWM and natural channel processes, but based on site observations is not expected to be significant.

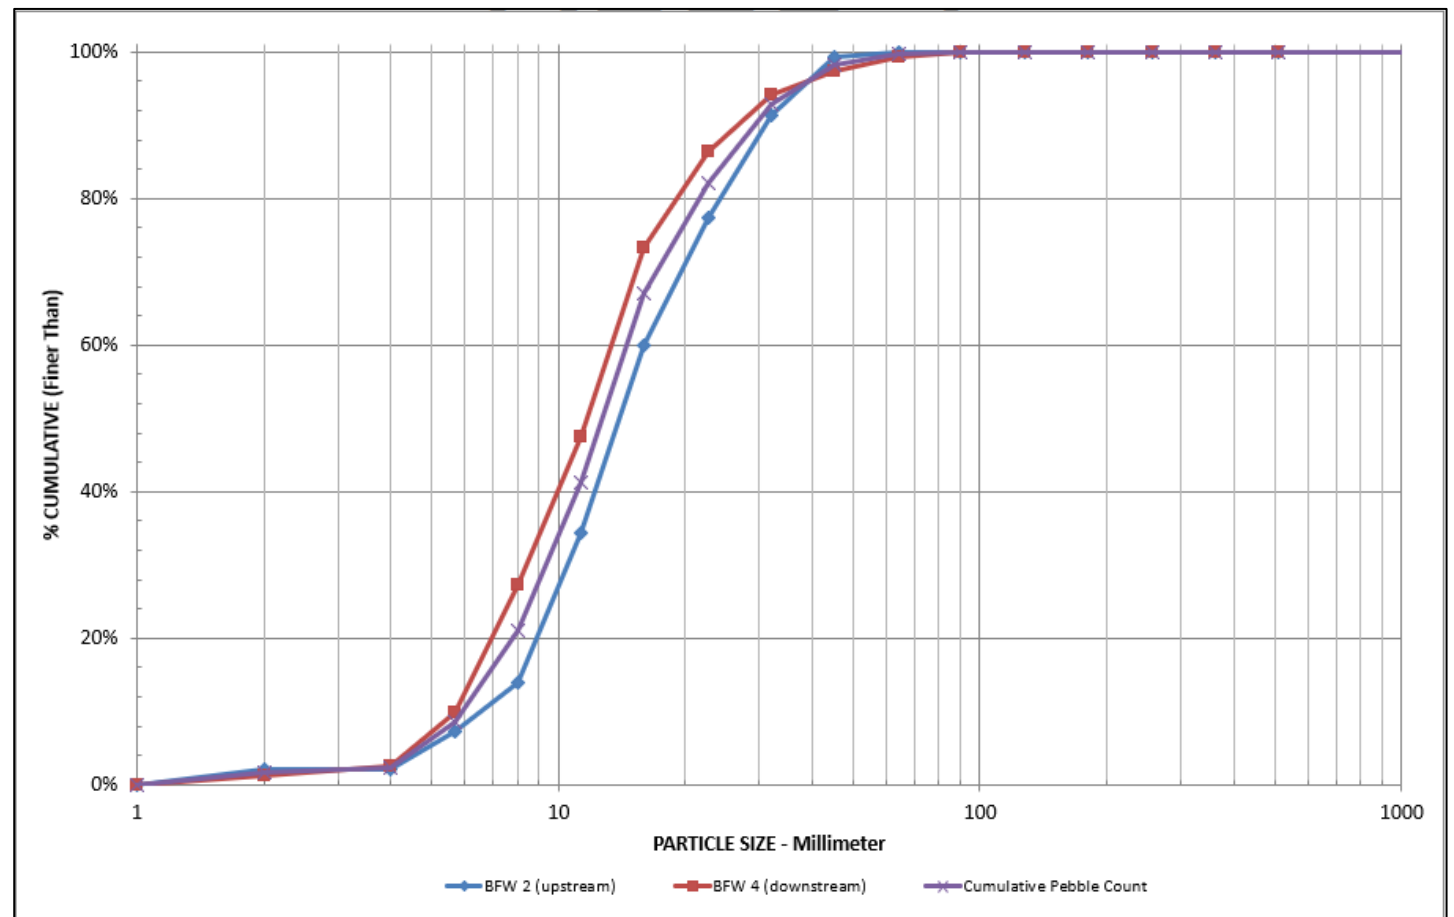
Figure 2: Sediment size distribution

Two pebble counts each of approximately 150 particles were performed. One upstream of the culvert and one downstream. Both pebble counts were done in the respective reference reaches, which are shown in Figure 1. Counts of 150 particles were deemed appropriate because of the length of the reference reach and the similar material size observed outside of the reference reach. The cumulative distribution and specific pebble sediment sizes are provided in Figure 2 and Table 2. Material primarily consisted of fine to coarse gravels and sand as shown in Figure 3.

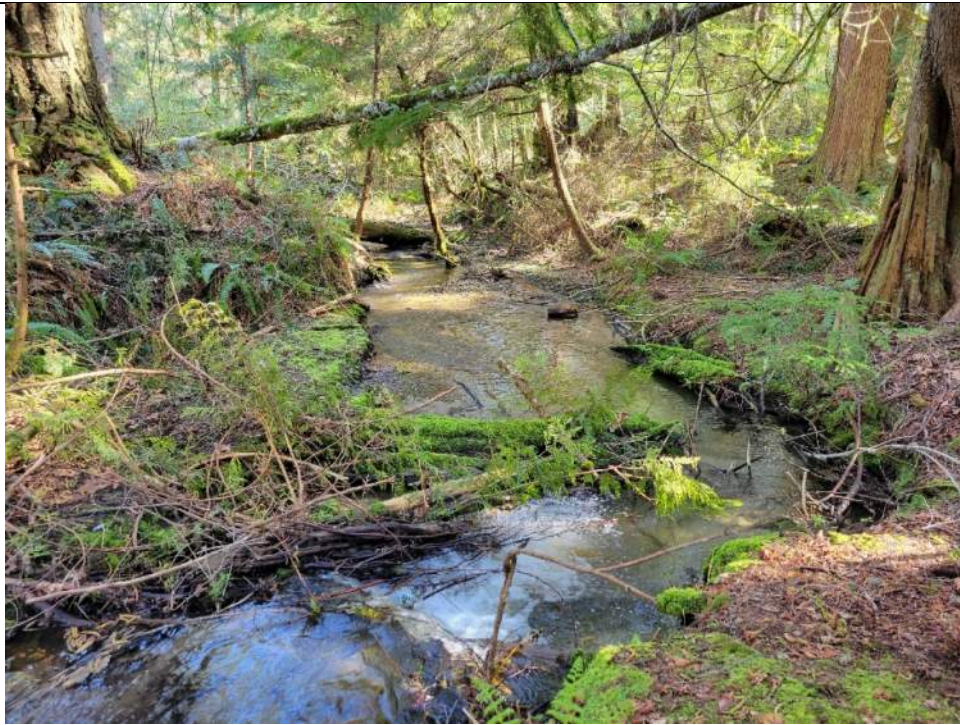
Figure 4: Upstream survey extents looking downstream

The upstream reach is characterized by a riffle pool morphology, meandering plan form, abundant LWM, and a bed comprised of gravel and sand. At the start of the upstream topographic survey limits the flow is immediately directed to the right bank by a channel-spanning log jam, see Figure 4. The flow then widens out to a relatively straight, shallow section with gravel bars along each bank. This is where the first BFW measurement (BFW 1) was taken, as shown in Figure 5. LWM along the left bank then constricts the channel again, which then flows under a channel-spanning log.

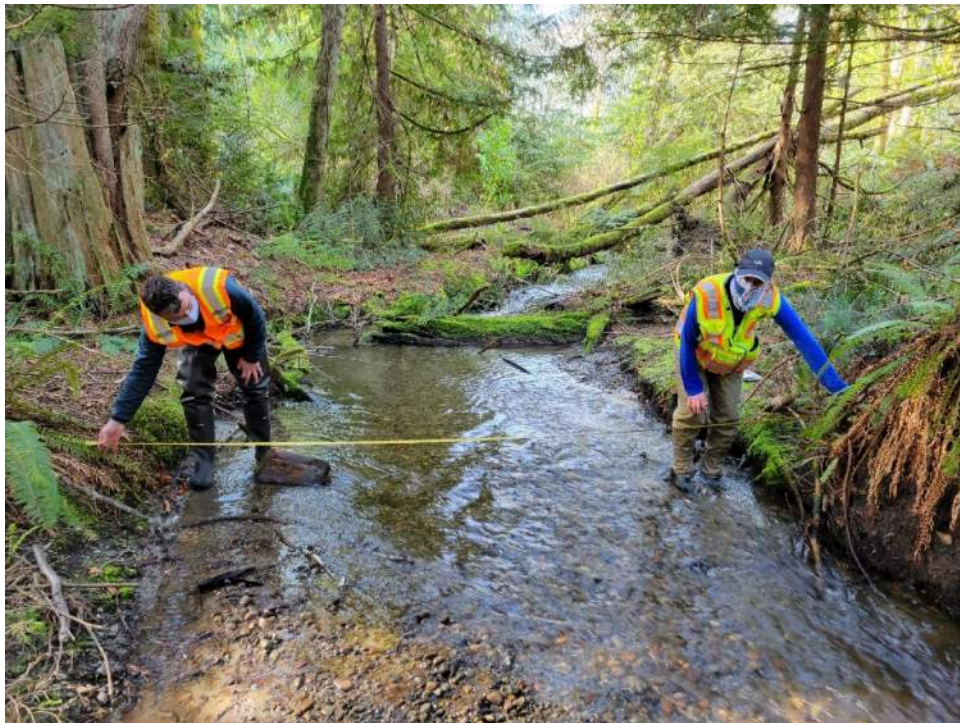
Figure 5: BFW 1 looking upstream

An upstream reference reach was identified approximately 180 feet upstream of the culvert inlet (Figure 1). The reference reach is located sufficiently upstream of the existing crossing and any associated backwater influences. Bankfull width (BFW) measurement 2 was taken within the reference reach in a relatively straight section of channel outside of backwater influence of the culvert and outside of the influence of LWM (large woody material) present in the reach. Cross section geometry in the reference reach will be used to inform channel design. Site conditions of the reference reach where the bankfull width measurement was taken can be viewed in Figure 5.

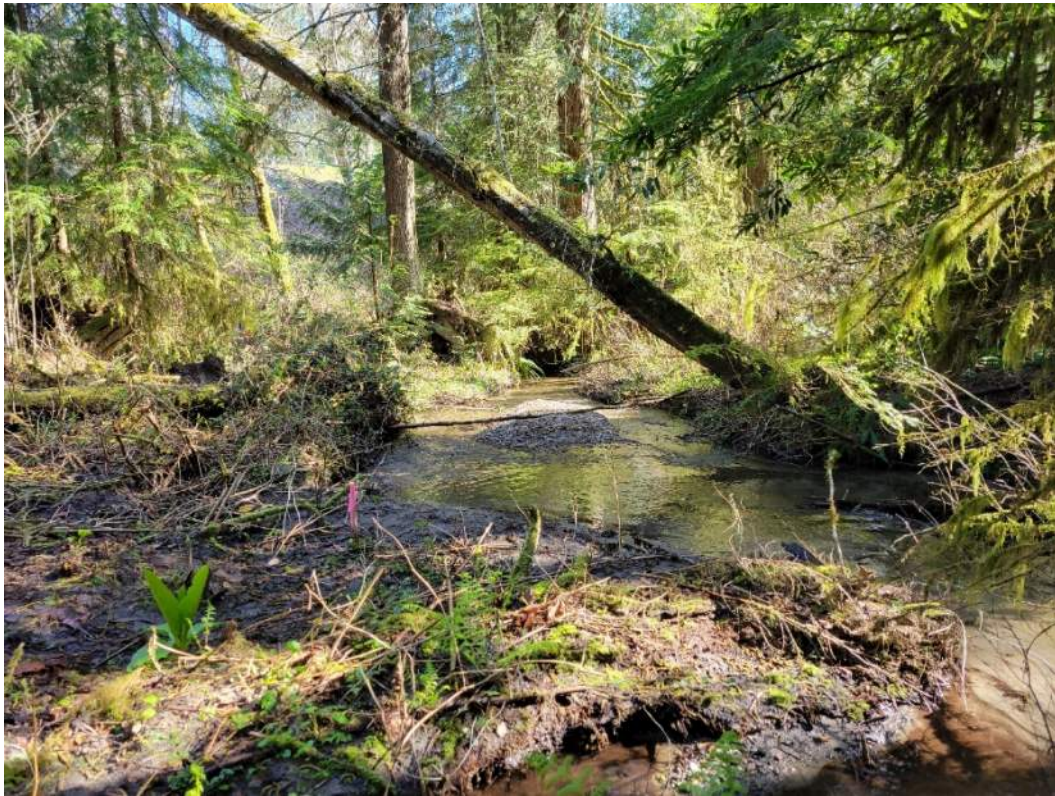
Figure 8: Mid-channel bar looking downstream

Downstream of the reference reach, the channel turns 90 degrees north before straightening out again. LWM on the left bank directs the channel against the right bank and then opens up to a straight section containing a mid-channel bar, shown in Figure 8. A small tributary (Tributary 2) enters the channel along the right bank at the mid-channel bar. This tributary has no known stormwater inputs but has similar features along it as found in Tributary 1 including groundwater seeps, saturated soils, and hydric vegetation. Downstream of the mid-channel bar, the channel narrows and flows under a log bridge formed between two stumps, see Figure 9. There is a gravel bar on the left side of the channel under the log bridge.

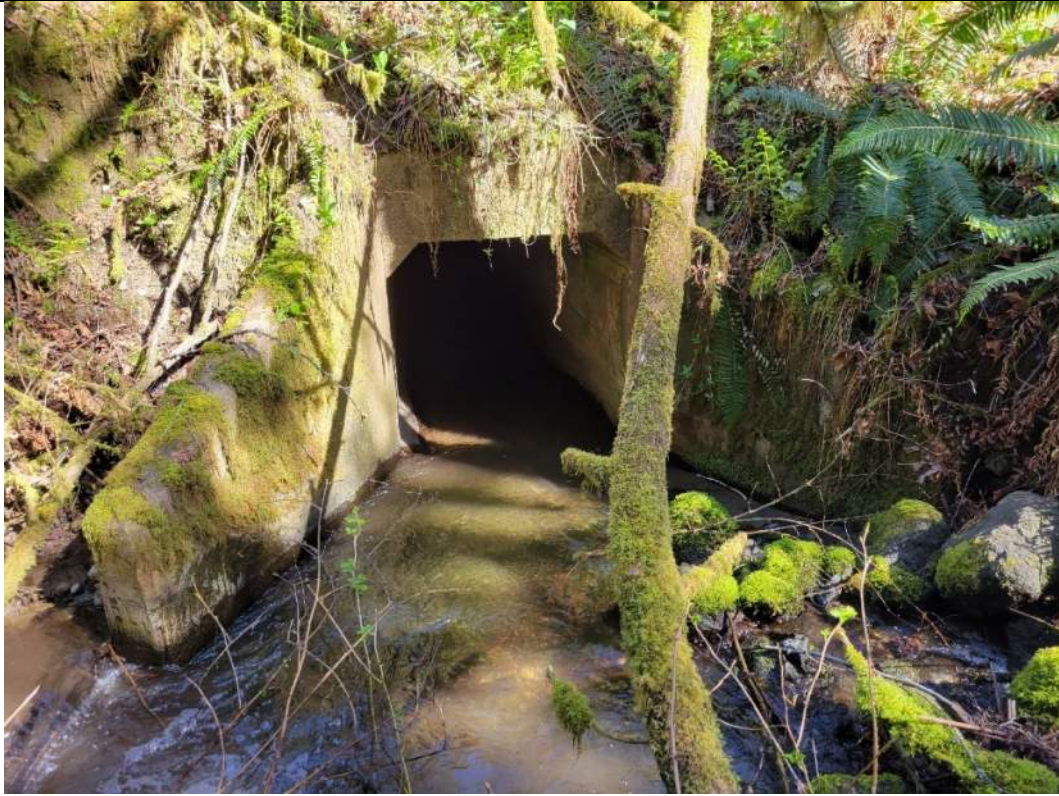
Figure 10: Culvert inlet

The existing culvert inlet is a 4 foot high by 4 foot wide four sided concrete box culvert. The culvert has 20 degree wingwalls, a short headwall, and a bottom apron that extends out as far as the wingwalls (Figure 10). The inlet did not have sediment accumulation in the bottom, but 10 feet downstream of the inlet the water surface drops approximate 1 foot due to accumulated woody material and large rocks. There was significant erosion along the left side of the inlet and behind the left wingwall. Flow at the culvert entrance was less than 6 inches deep and visually estimated at 3-5 cubic feet per second on the day of the site visit. Road fill slopes on both sides of the crossing exceed 2:1.

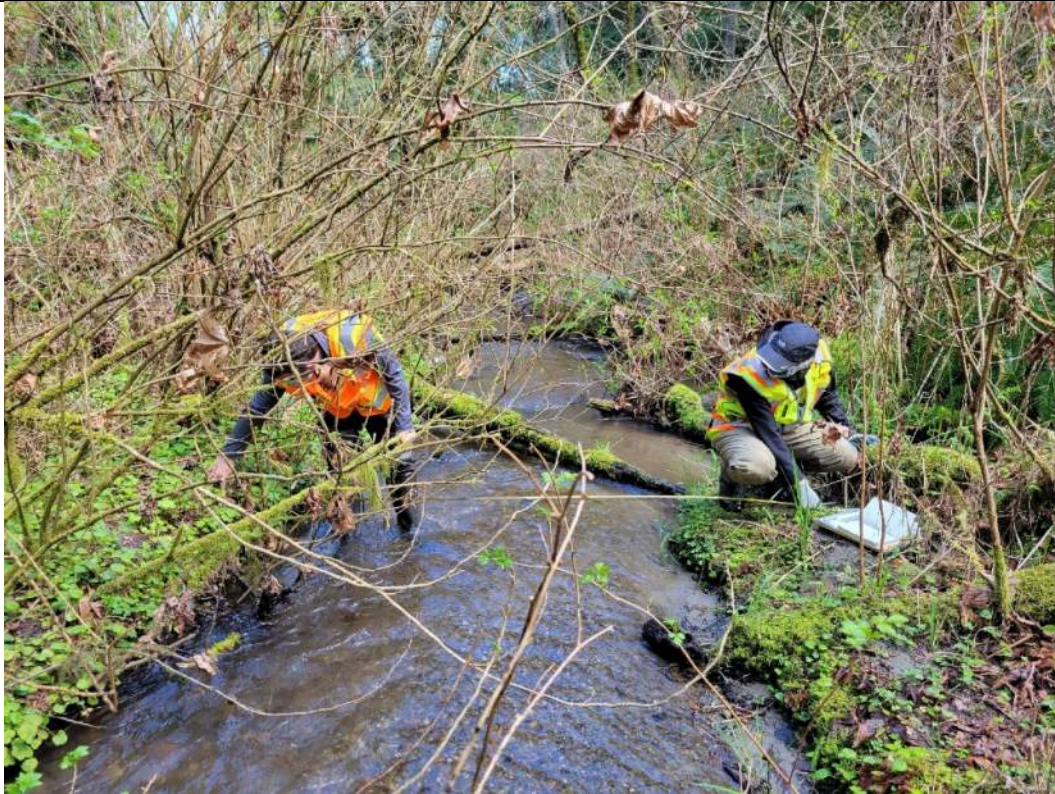
Figure 16: BFW 4 looking downstream

The downstream reference reach was identified approximately 315 feet downstream of the culvert outlet (Figure 1). BFW measurement 4 was taken within this reach. The channel is relatively straight with a steeper channel slope than the upstream reference reach. Comparison of this reference reach slope to the longitudinal profile from survey data, appears to better match the longitudinal profile slope. While the slope is steeper in the downstream reference reach, the cross section geometry is very similar to that found in the upstream reference reach. Site conditions of the reference reach where the bankfull width measurement was taken can be viewed in Figure 16.

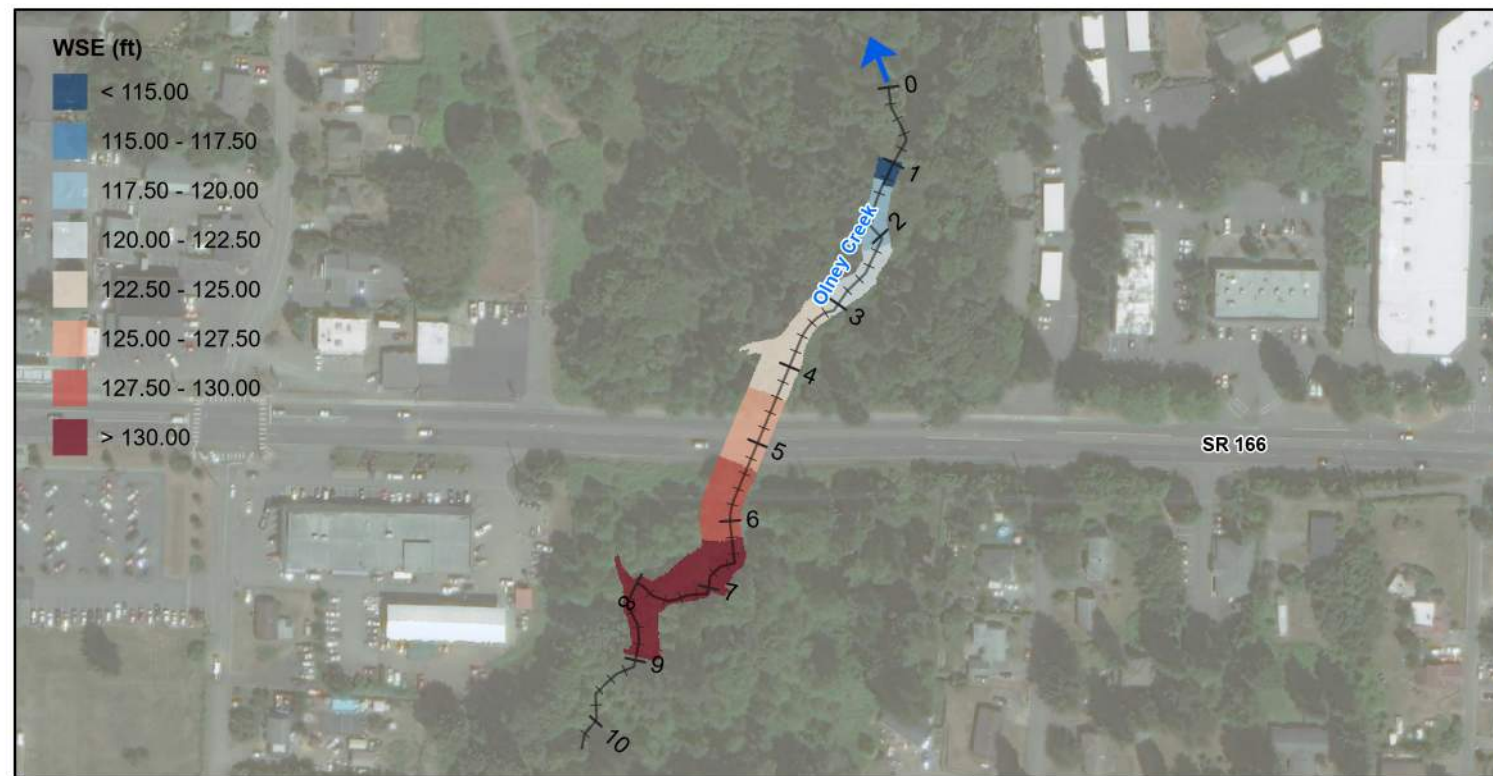
WATER SURFACE ELEVATION

NATURAL CONDITIONS 100-YEAR

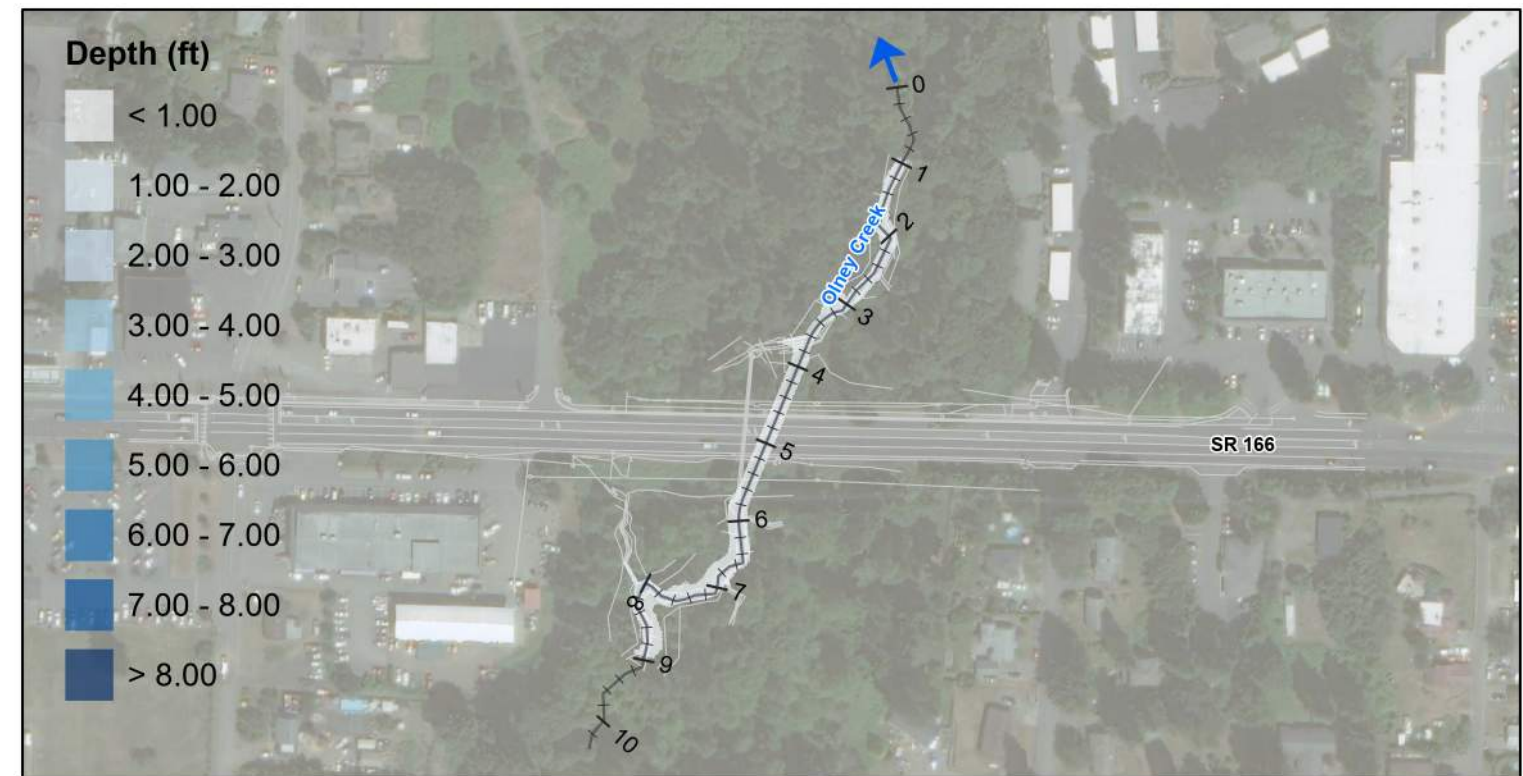
DEPTH

NATURAL CONDITIONS 100-YEAR 2080

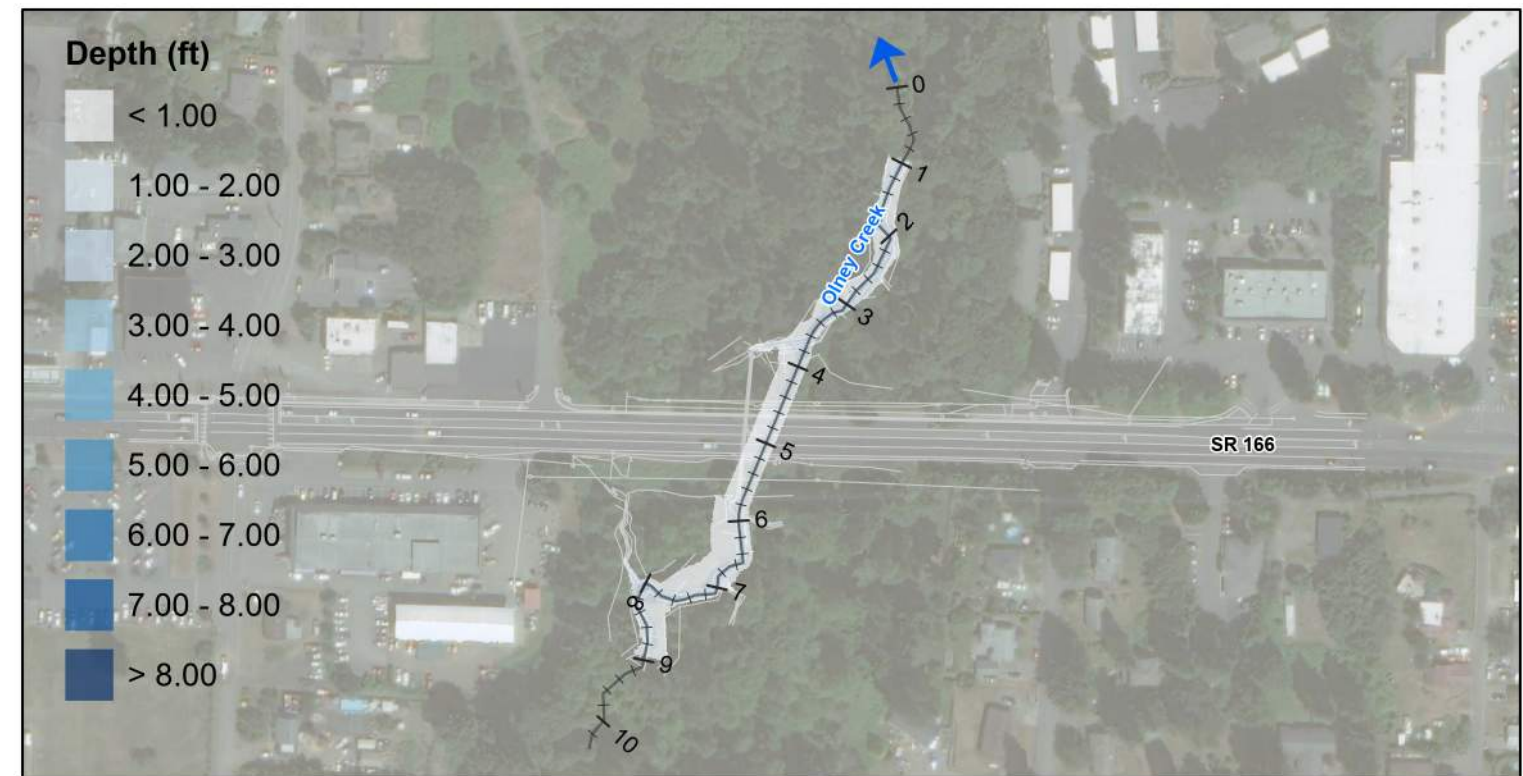
DEPTH

PROPOSED CONDITIONS 2-YEAR

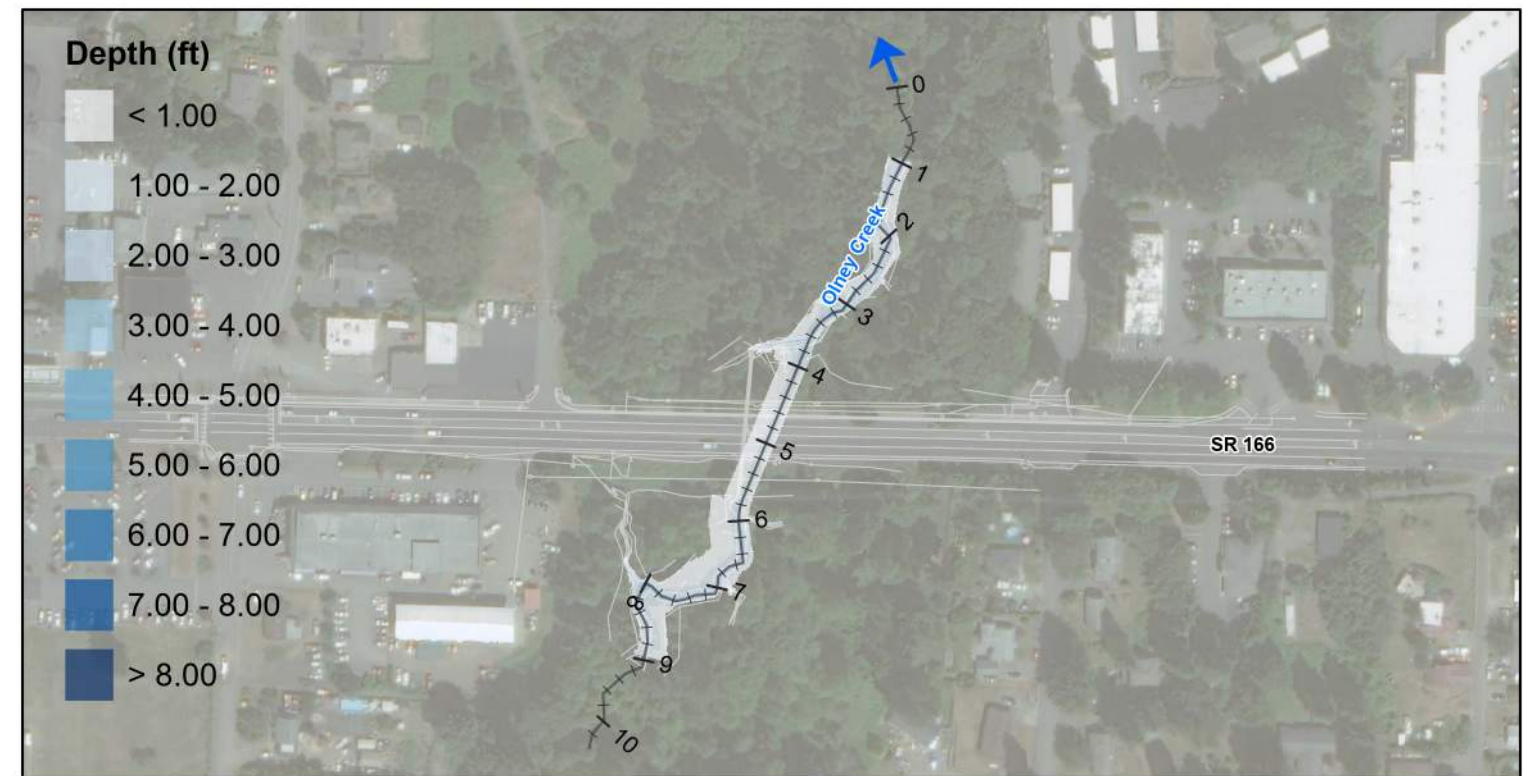
DEPTH

PROPOSED CONDITIONS 100-YEAR

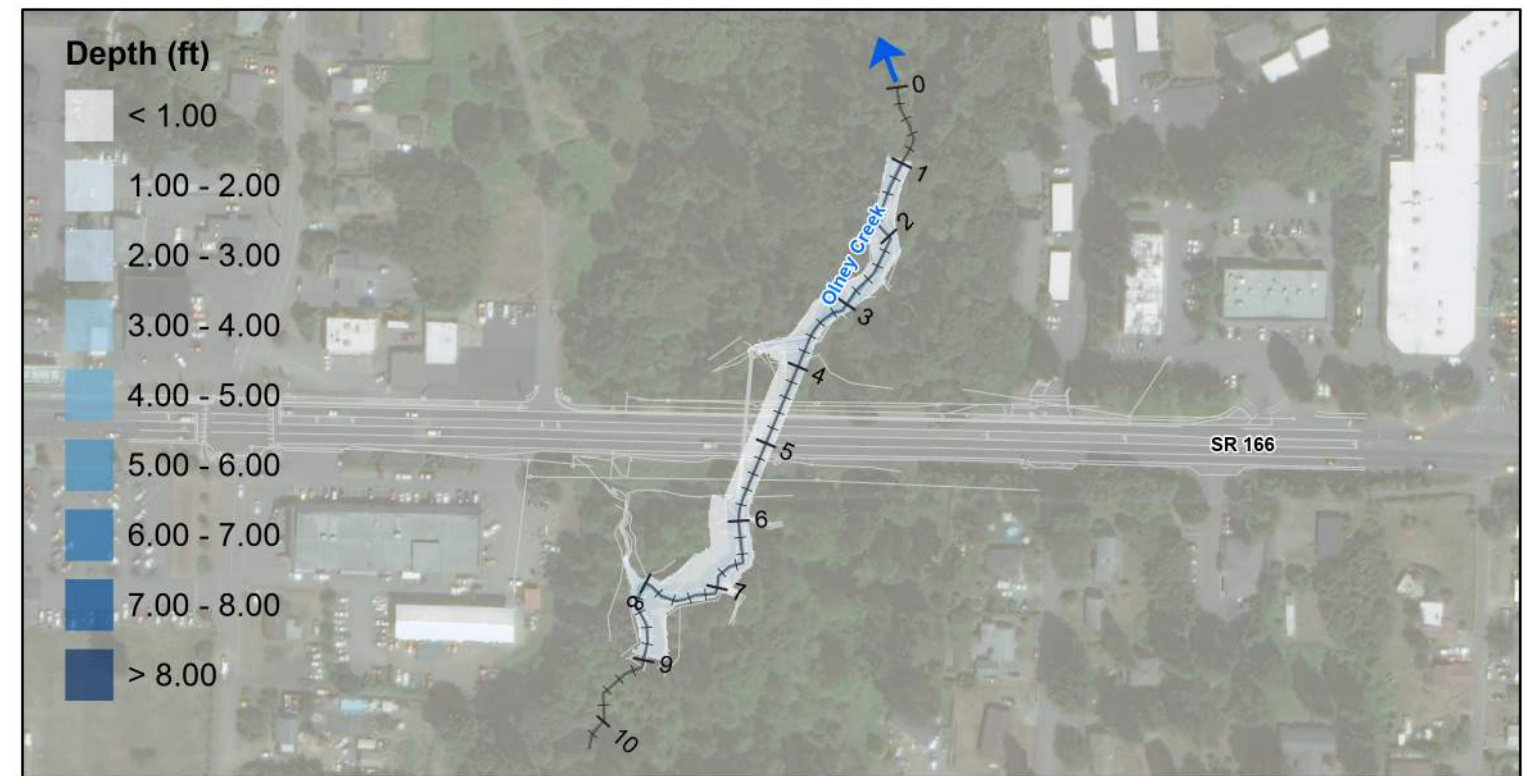
DEPTH

PROPOSED CONDITIONS 500-YEAR
